# Manhole Inspection Summary

Manhole # S55E\_\_036MH

Insp Date: **7/22/08 1:59 PM**

**Location** Address: **201s eaton st**

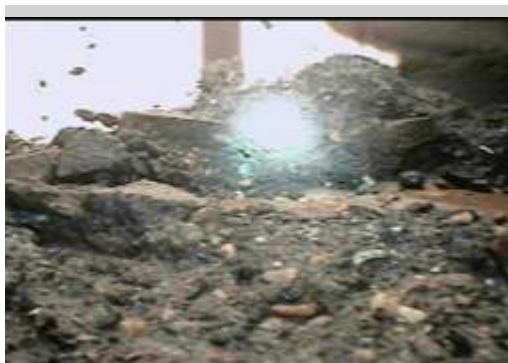
Defect 3

Condition: ☐ Sound ☐ Cracked ☐ Root Intrusion ☐ Deteriorated ☐ Leaks ☒ **Debris**

channel debris

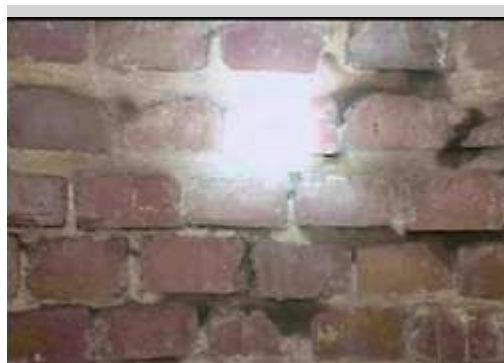
Defect 2

Condition: ☐ Sound ☐ Cracked ☐ Root Intrusion ☐ Loose Brick ☒ **Deteriorated**

barrel

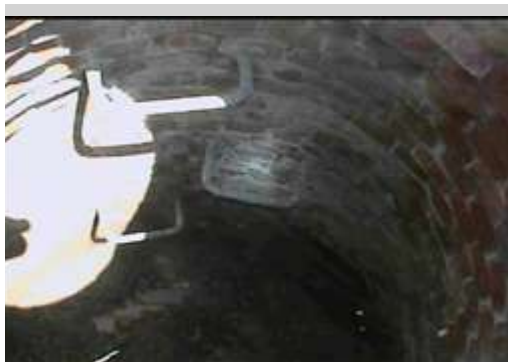
Defect 1

Count: **3** Missing: **0** ☒ **Corroded**

steps
